The Old Water Works Archaeological Project,

Bethlehem, Pennsylvania, 1964

Vincent P. Foley

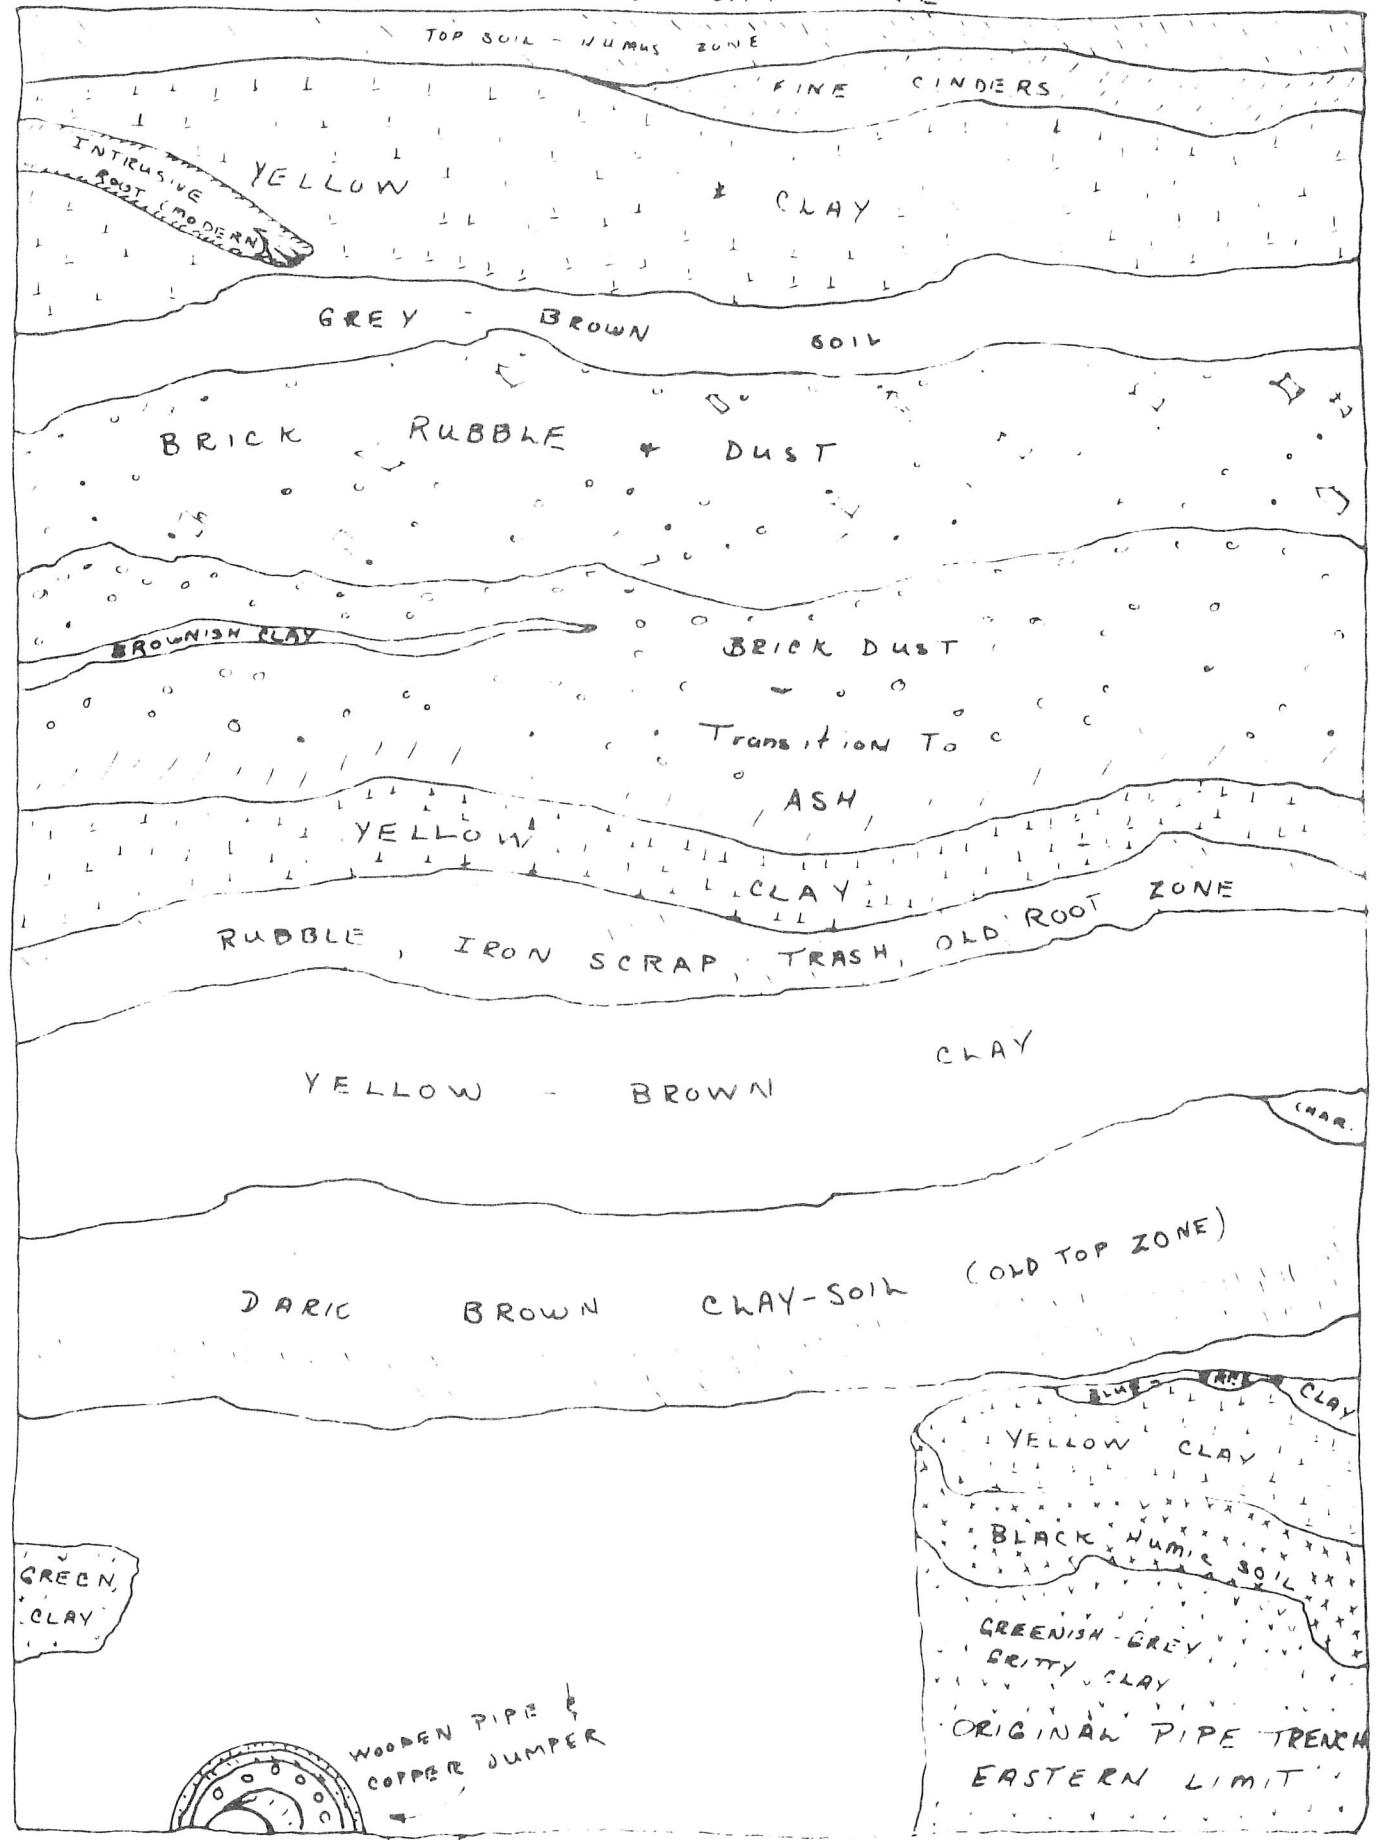
FIGURE II

Stratigraphic Profile - E Section - 40S/160W (SEE PLATE XII-A)

SURFACE & DATUM LINE

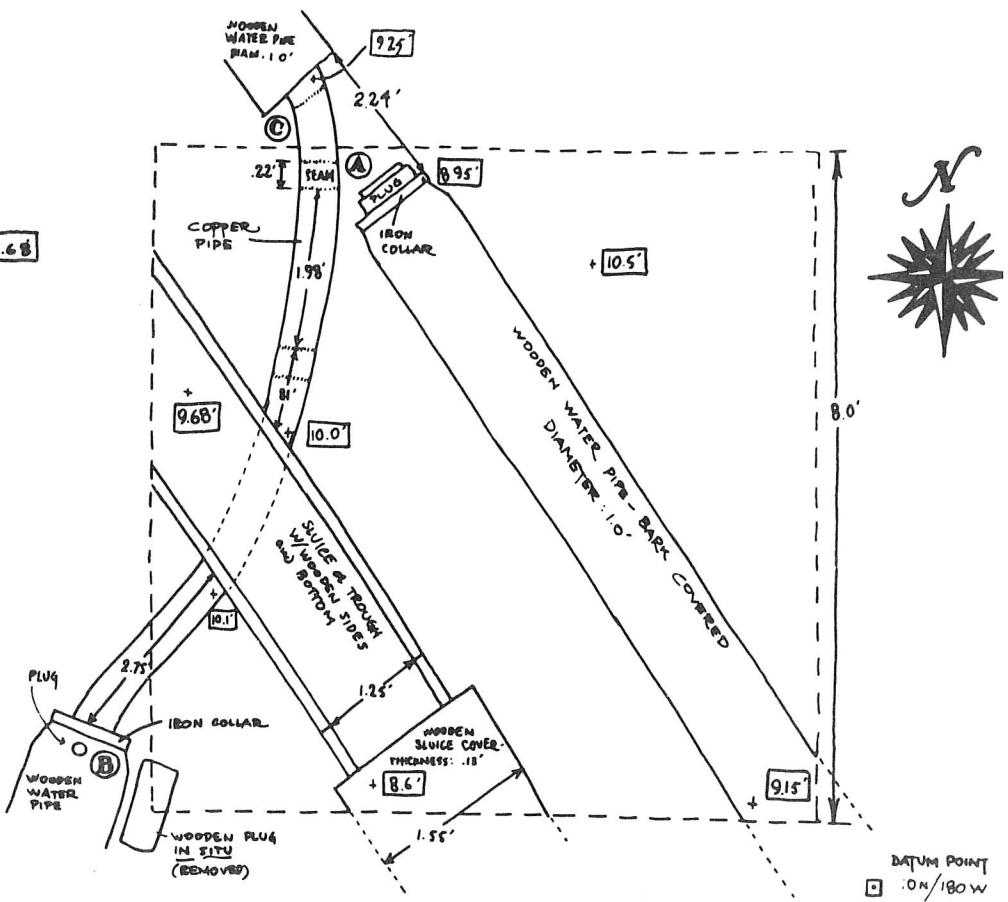
TEST PIT 1. 10N/100W

NOT DRAWN TO SCALE

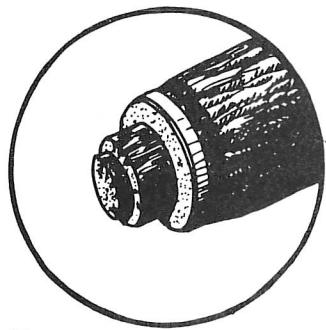
(A) Wooden pipe with iron collar and double plug arrangement to close it off. Added to pit collar.

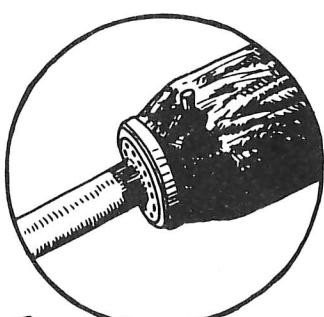
(B) Wooden water pipe with iron collar and small plug. Copper jumper attached to copper flange, with 14 studs. Wooden pipe is added to pit collar. This pipe is about 4-5" larger in diameter than (A) or (C).

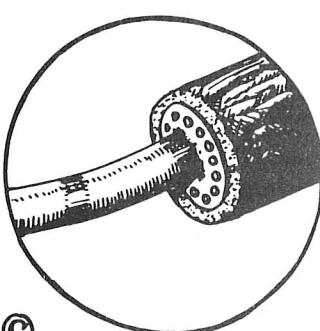
(C) Wooden water pipe with no collar. Copper pipe used as jumper to (B). Wooden pipe is not added down.

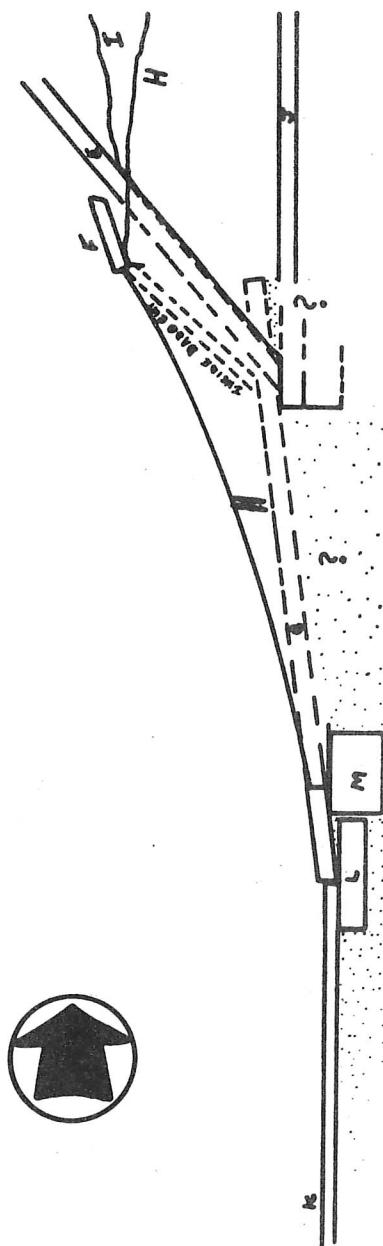
PLATE X

HEAD RACE ARCH

WHEEL PIT WALL

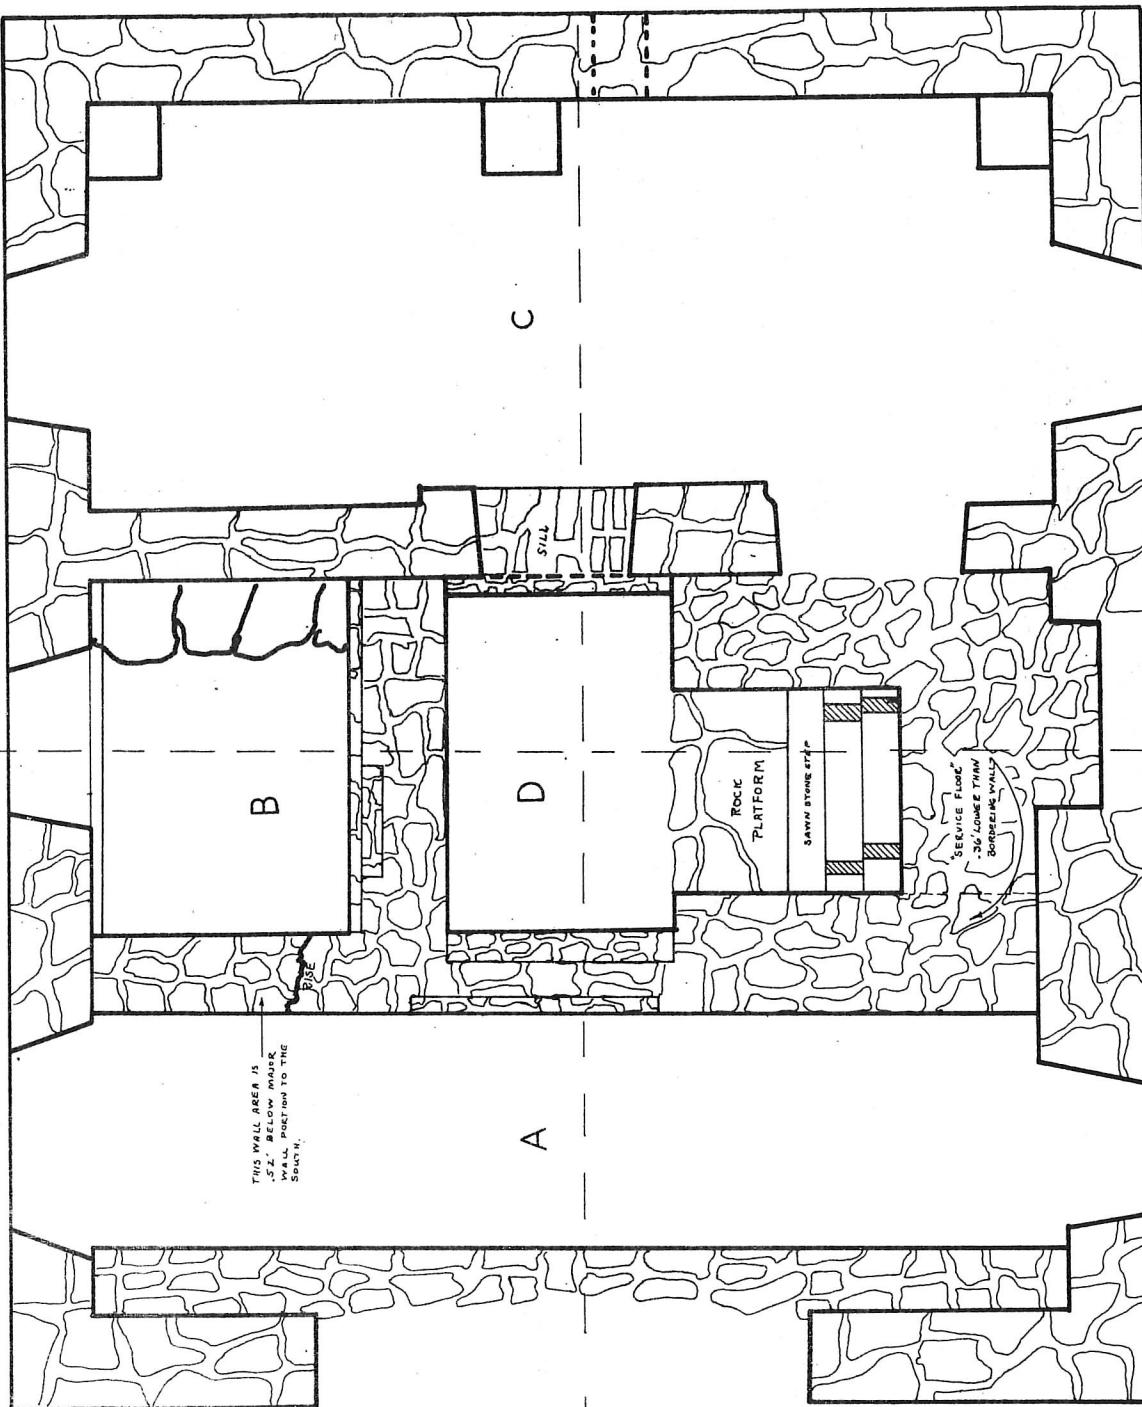
OLD WATERWORKS

EXCAVATED FLOOR PLAN  
WITH PROFILE LINES
